# Monitoring Failure Sequence in Cold-sprayed Al6061 Deposits Using Acoustic Emission

## ABSTRACT

Keywords: Acoustic Emission; Cold Spray; Al6061; Crack; Delamination; Non-destructive Test

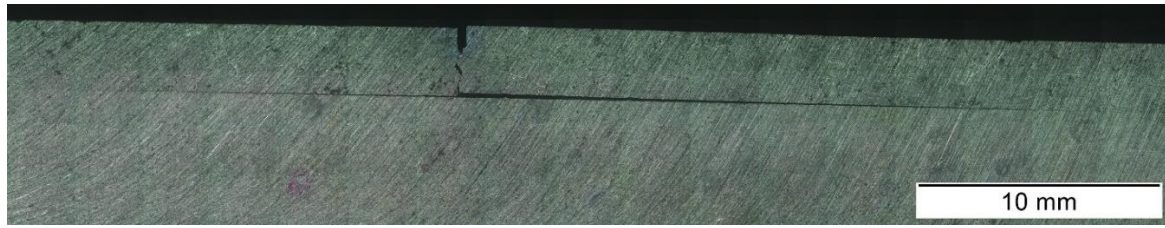
*Fig 3. (a) Cross-sectional micrograph of the 1mm precut sample after four-point bending test and SEM image from the delaminated interface showing (b) cold sprayed deposit with presence of flattened Al6061 powder particles and (c) Al6061-T6 substrate surface decorated dominantly with craters bombarded by Al6061 powder particles.*

After conducting the four-point bending test on the precut sample, the crack can be clearly observed below the precut notch, and the delamination between the deposit and the interface is also visible. The cross-sectional micrograph of the tested sample with 1mm precut is presented in Fig. 3(a). Additionally, SEM analysis of the delaminated Al6061 deposit exhibits the presence of flattened powder particles (Fig. 3(b)). In contrast, the Al6061-T6 substrate surface is predominantly decorated with craters, with occasional Al6061 particles remaining (Fig. 3(c)). The SEM images clearly reveal that the delamination took place between the cold-sprayed Al6061 deposits and the Al6061-T6 coupon.

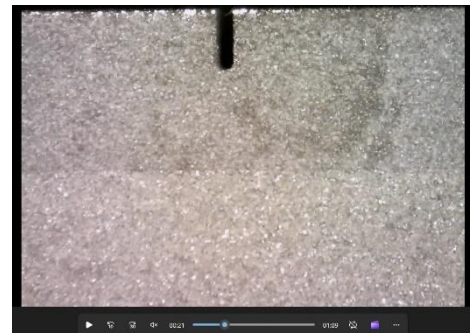
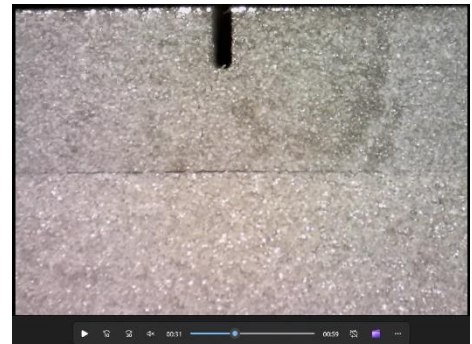
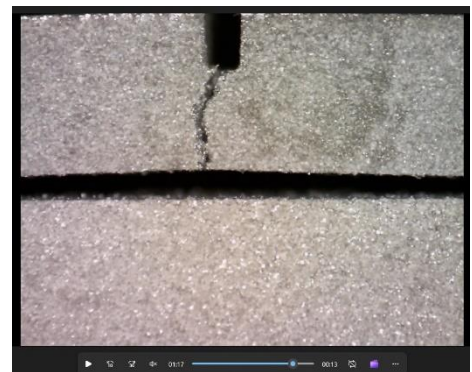
*Fig.4 (a) An overlap of load-time curve with individual acoustic emission event during four-point bending test of coupon with 1mm precut. (b, d, f) Detected acoustic emission frequency by WD sensor (red) and F15a sensor (blue) at 21.7, 31.3 and 76.6 seconds, respectively, as well as (c, e, g) snapshots of the coupon from the video captured during the four-point bending at the corresponding timing of 21.7, 31.3 and 76.6 seconds.*

A typical AE acquisition during a four-point bending test of a coupon with a pre-cut (Fig. 2(b)) is shown in Fig. 4(a), overlapped with the loading-time curve extracted from the Instron 5900R at 0.5 mm/s loading rate. Each scattered red square and blue dots represent an individual **acoustic emission (AE)** event detected by the Mistra WD or F15a sensors, respectively. The first **AE** emission event was detected at 21.7 s at a load of 1178.4 N, 2.2 s ahead of the yielding point at 23.9 s and 1246.7 N (marked by green downward arrow in Fig. 4(a)). After yielding, there was a sharp drop in loading force within 0.9 s to 1198.6 N till 24.8 s, followed by a plateau in loading force which remained stable at 1198 N till 37.7 s. Subsequently the loading force continued to increase linearly with time. The corresponding video can be found in the Supplementary Information.

delamination between the CS deposit and the substrate continued to propagate from the center towards the inner two pins (Fig. 4(g)). The gap between deposit and substrate increased concurrently with the outward delamination growth. The corresponding frequencies of the acoustic emissions were in the low frequency range ( $< 100$  kHz) for both F15a ( $\sim 51.0$  kHz, blue curve) and WD sensors (dominated with  $\leq 200$  kHz, red curve, Fig. 4(f)) and had a duration of 1120  $\mu$ s. Typically, high frequency and lower frequency AE events are associated with small scale and larger scale failure events, respectively [31]. For example, delamination along the deposit/substrate interface typically would involve a much larger area of failure when compared to cracks within the deposits. A correlation of a delamination event to the low frequency components seen in the FFT spectrum can also be confirmed by the captured image (Fig. 4(g)), where the delamination of the deposit and substrate dominates all other failure mechanisms. Similar frequency characteristics have been reported in plasma sprayed thermal barrier coatings, where the AE signature of cracks and delamination were 100 to 300 kHz and  $<100$  kHz, respectively [32,33].

On the contrary, at the first detected acoustic emission events at 21.7 s (Fig. 4(b)), the real time image (Fig. 4(c)) showed no indications of either crack or delamination on the external surface, even after zooming in the image. The high frequency components within 200 to 300 kHz were captured by both sensors (Fig. 4(b)). This AE event had a duration 183  $\mu$ s and was likely to be emitted from cracking within the deposit, starting from regions where the adhesion was weak. At this point of time, the first crack has yet to propagate to the external surface and hence was not visible under the camera.

In short, when comparing the acoustic emission events at 21.7 s and 76.6 s (Fig. 4(f)), a clear distinction emerges between these two types of AE events. The high frequency components at 21.7 s correlates with a cracking failure mechanism and the low frequency components at 76.6 s are shown to be related to delamination. Other two discrete frequencies

An intermediate timing between 21.1 and 76.6 s, i.e., 31.3 s, was picked up for further analysis and verification. At 31.3 s, delamination at the interface can be seen visually while cracking can be identified under the precut, as seen in Fig. 4(e). As a result, both low (63.0 & 69.9 kHz) and high (210.6, 227.4 & 288.9 kHz) frequency events have been picked up by both sensors (Fig. 4(d)), indicating the concurrent occurrence of both cracking and delamination events.
