Influence of double vacuum debulking process on co-cured soft-patch carbon fibre composite repairs

Published in: Composites Part B 168 (2019) 367–374

Abstract

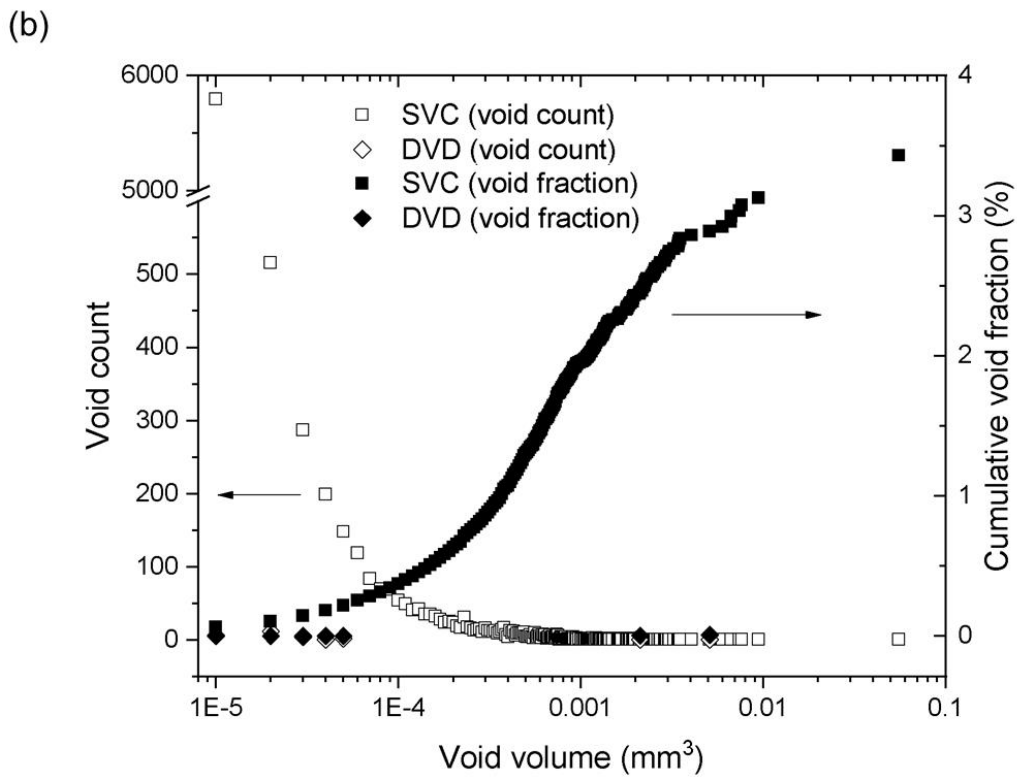
Fig. 2: X-ray micro-CT porosity analysis showing (a) porosity locations and (b) void counts and void fraction with respect to void size

allowed for clear visualization of fibre bundles in relation to porosity distribution. Large spherical porosities (diameters up to 100-150 μm) accumulated in the resin-rich regions between the prepreg layers and around warp/weft cross-overs. Within the fibre bundles, smaller porosities with high aspect ratios aligned with the carbon fibres were found. Tserpes et al [27] reported similar results for autoclave panels cured at reduced pressure. As shown in Fig. 3b, the additional DVD pre-curing step resulted in an almost void-free laminate with negligible porosity of $0.2 \pm 0.1\%$, and the process was therefore able to remove most solvent and volatiles. This is comparable to the autoclave cured laminate which is also void-free (Fig. 3c). Finally, no dry regions in between fibres were found in any specimens.

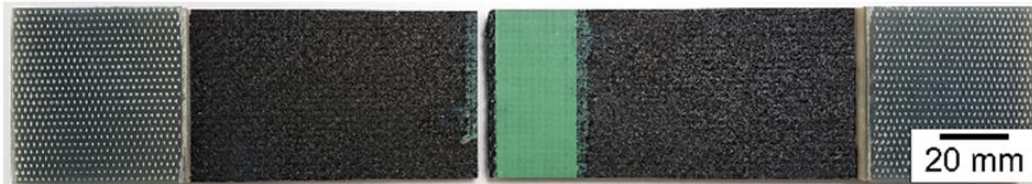
Fig. 10: Failure locations of scarf lap joints and 2D scarf repair

(b) 2D SVC repair

Brittle fracture in the form of sudden catastrophic failure and straight fracture surfaces was observed in both the scarf lap joint and 2D repair specimens. The scarf lap joint failure initiated at the end of the scarf, with some cohesive failure observed along the adhesive layer from the failure location prior to the crack propagating through-thickness into the parent material, as shown in Fig. 10a. Some specimens also show extensive delamination in the composite starting from the location of cohesive failure. For both types of 2D repair specimens, the crack propagates straight into the soft patch without any evidence of cohesive failure or delamination, as shown from the bottom view in Figs. 10b and 10c. It is likely that failure again initiated at the interface between the parent and patch at the tip of the scarf where the stress concentration is high [37]. The resin-rich regions along the adhesive bond line may have caused this difference in failure mechanism, but this effect is not significant in terms of the strength results as shown for the DVD process. The findings overall indicate that the effect of discontinuous fibres, ply tip stress concentrations as well as porosity were contributing and dominant factors for the resulting repair strength.

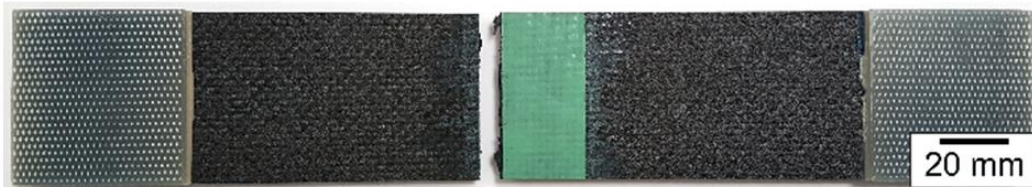
(c) 2D DVD repair
