Out-of-autoclave scarf repair of interlayer toughened carbon fibre composites using double vacuum debulking of patch

Published in: Composites: Part A 107 (2018) 224–234

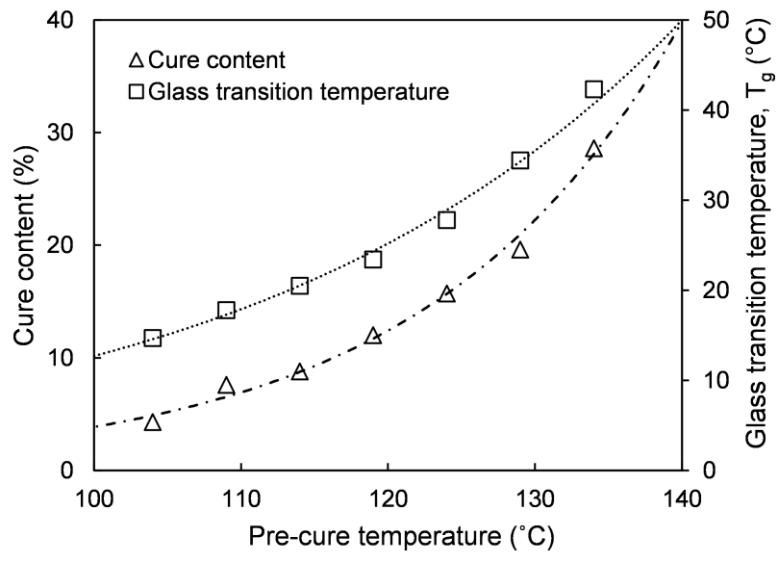
Figure 3: Cure content and glass transition temperature of pre-cured prepreg.

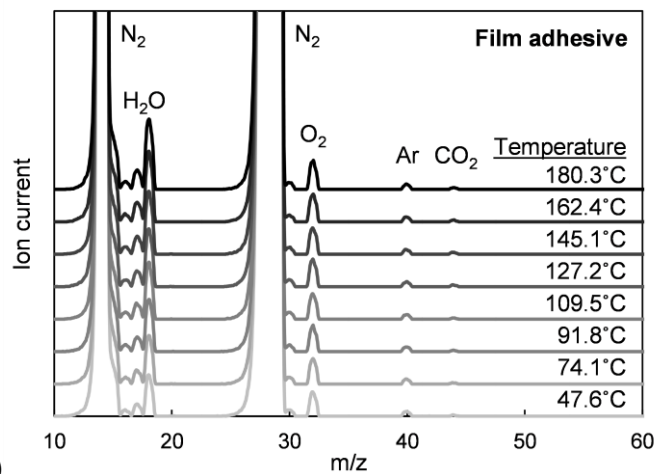
Figure 4: Temperature scan plots from mass spectroscopy with (a) relative weight loss and water release profile from prepreg and film adhesive during heating phase, (b) mass spectroscopy scan of prepreg material with temperature ramp, and (c) mass spectroscopy scan of film adhesive with temperature ramp.

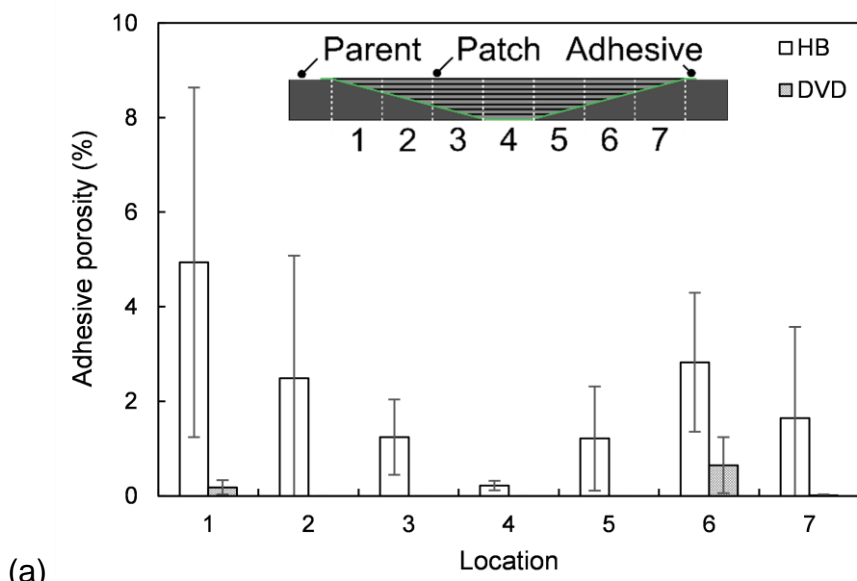
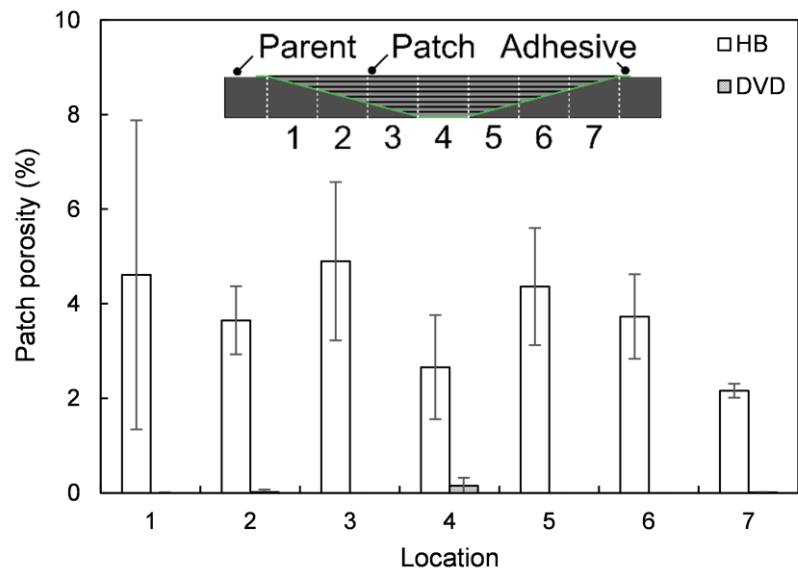
Figure 8: (a) patch and (b) adhesive porosity in 3D repair.

We also confirmed the detrimental role of the film adhesive with regard to porosity for the 3D repair specimens. An overview of the representative porosity results for both patch and adhesive as a function of repair location can be found in Figure 8. As this specimen has an angled patch geometry, the porosity was analysed in sections as indicated in the figure, with at least three randomly selected locations evaluated for each data point. Firstly, it can be seen that the porosity content is again consistently high for hotbonding cure within the repair patch and mostly independent of section location. The average porosity content in the 3D repair agrees well with those measured from the 1D repair specimens with an average of $3.9 \pm 1.2\%$ in the patch and $1.6 \pm 1.5\%$ in the adhesive for the hotbonding cured 3D repairs. In comparison, the DVD cured 3D repairs are almost void-free, with an average porosity of $0.1 \pm 0.1\%$ in both the patch and adhesive. The decrease in porosity in the adhesive by applying the DVD process on the patch again gives evidence to the argument that prepreg volatiles become trapped in the adhesive film layer. It is also noted from the 1D versus 3D repair comparison that the fully cured composite structure underneath the repair patch does not contribute to further porosity increase.

gradually decreases towards the upper surface of the patch (shortest path to the vacuum source). Meanwhile, the centre of the repair (location 4) contains fewer voids on average, as shown in Figure 8, and the porosity distribution is fairly uniform across the thickness. The 1D repair laminate with the film adhesive at the lower surface has a different porosity distribution, where the highest porosity was found in the lower and centre part as shown in Figure 9(b). The difference in porosity distribution is the result of the restricted volatile escape path due to the presence of cured CFRP and adhesive film. In contrast, standard hotbonding curing for laminates without adhesive presence yields a fairly uniform void distribution of only 0.5%. 1D repair laminates are therefore identified as more representative designs to mimic repair porosity content as the maximum porosities in the 1D and 3D repairs of 8% are of similar order of magnitude. As some of the mechanical laminate properties are highly sensitive to porosity, it is important to achieve a similar void content to ensure that the property degradation results are representative.

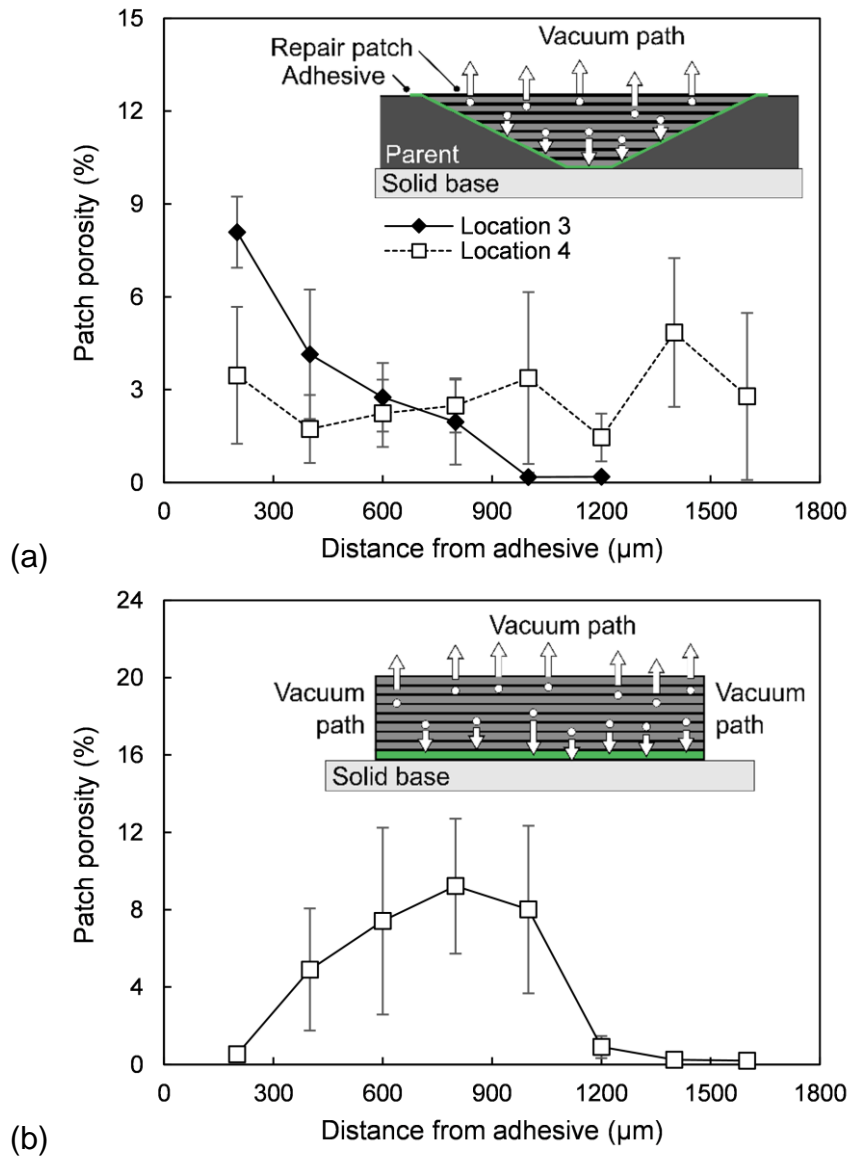
Figure 9: Porosity analysis of patch versus distance from adhesive layer for repair with hotbonding curing for (a) 3D repair and (b) 1D repair. The total laminate thickness is 1.8mm.

Additionally, it can be noted from the through-thickness optical micrographs that the porosity distribution across the thickness of the patch is not necessarily uniform. The analysis of the hotbonding cured 3D repair across the entire thickness at locations 3 (near the tip of the scarf) and 4 (centre hole) is shown in Figure 9(a). At location 3, it was found that the region closest to the adhesive exhibits the highest porosity, which

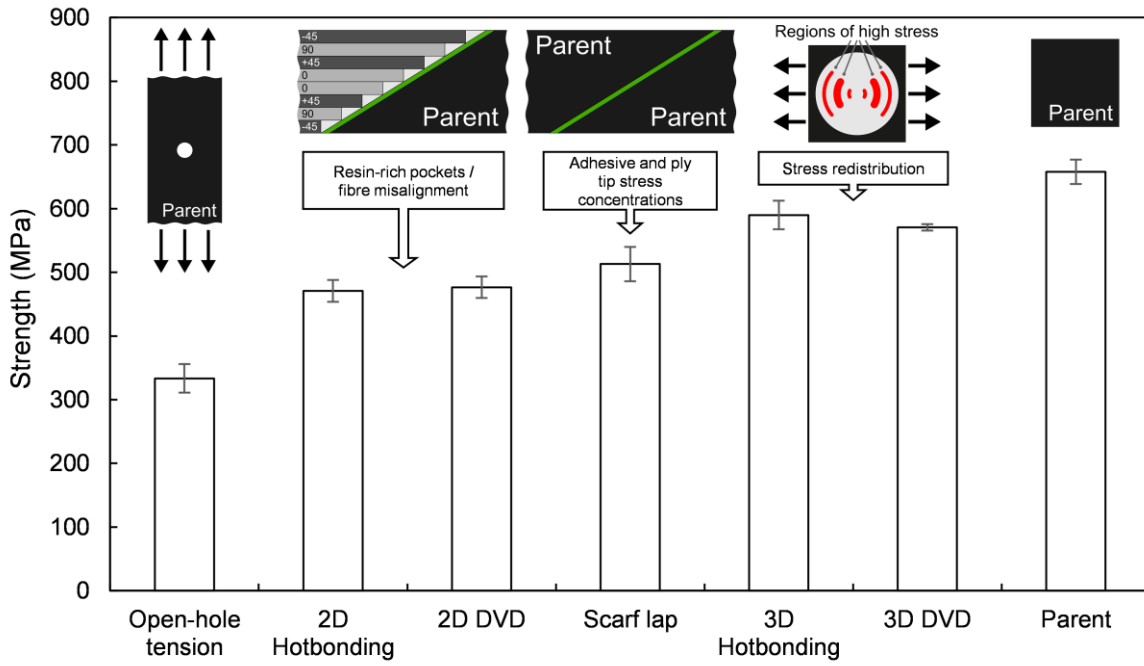
Figure 10: Strength comparison of open-hole tension, 2D repair, scarf lap, 3D repair, and parent material. Repair strength exceeds open-hole tensile strength benchmark.

The repair strength results are summarized in Figure 10, together with a comparison with the open-hole, scarf lap joint and the parent material strengths. Sudden catastrophic failure was observed for all tests, and localized strain gauge readings and global digital image correlation (DIC) measurements were not able to indicate any locations of non-uniform strain increase prior to failure.

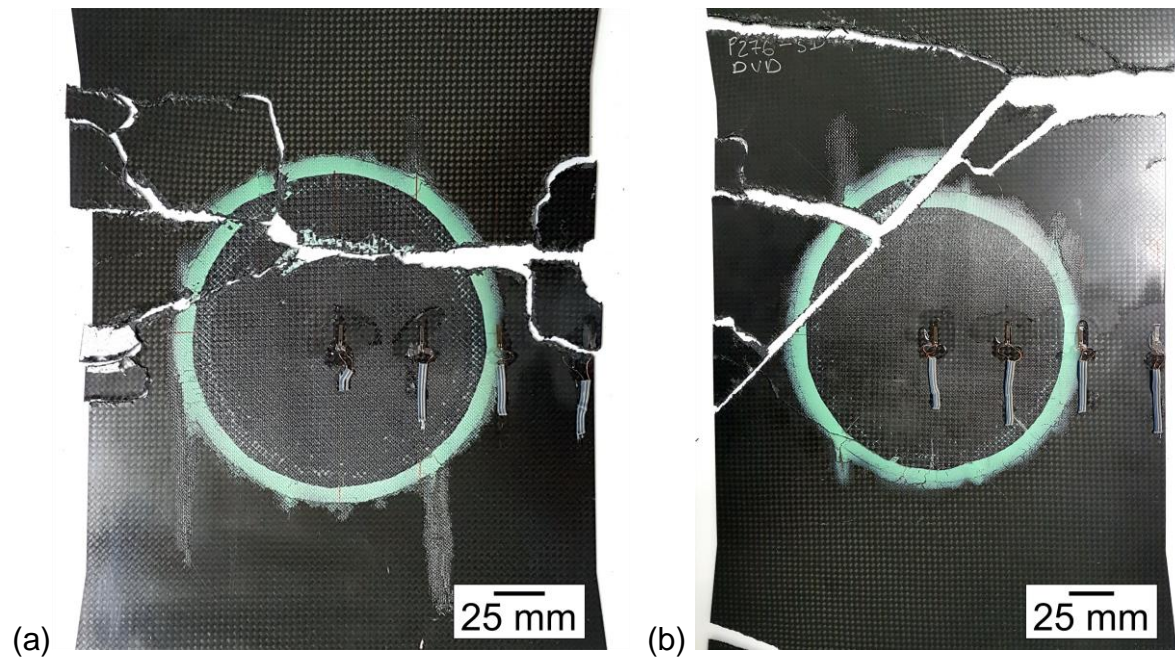
Figure 12: Representative failure patterns of 3D scarf repairs for (a) hotbonding and (b) DVD process.

and parent laminate as shown in Figure 12. Both 2D and 3D repairs exceed the open-hole tensile strength benchmark as required.
